Addendum #1

RFP #26-08 Bridges Repair & Maintenance

BARNETTS BRIDGE RD over JACKSON LAKE

Bridge #035-0019-0(Routine)

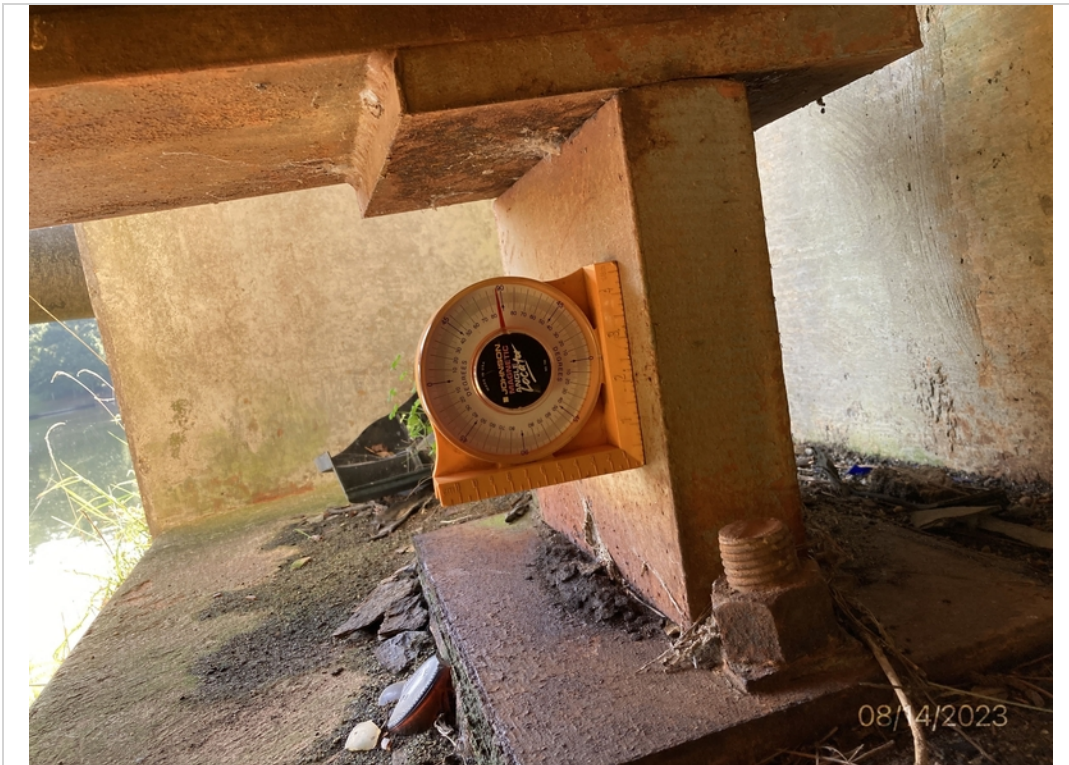
Abutment 1, beam 2 has a loose nut on the bearing assembly.
Abutment 1, bearing 5 has moderate rust; masonry plate has sheet corrosion with minor section loss. (photo)

Abutment 1 bearing 5. 2023

Activity	Priority	Location	Comments
550-Erosion control	B	Abutment 4 left and forward approach slab	Repair erosion under left end of abutment 4 cap and forward approach slab; left side.
800-Bridge Joint Sealing	C	Abutment #1, bent 2 and 3 joints	Repair Abutment 1 joint; seal intermediate deck joints.
000-Bridge Painting	C	Beams and bearings	Steel beams and bearings need to be cleaned and painted.
830-Repair Main Structural Members	B	Bearings and masonry plates at both abutments	Repair bearings and masonry plates with sheet corrosion and section loss at both abutments.

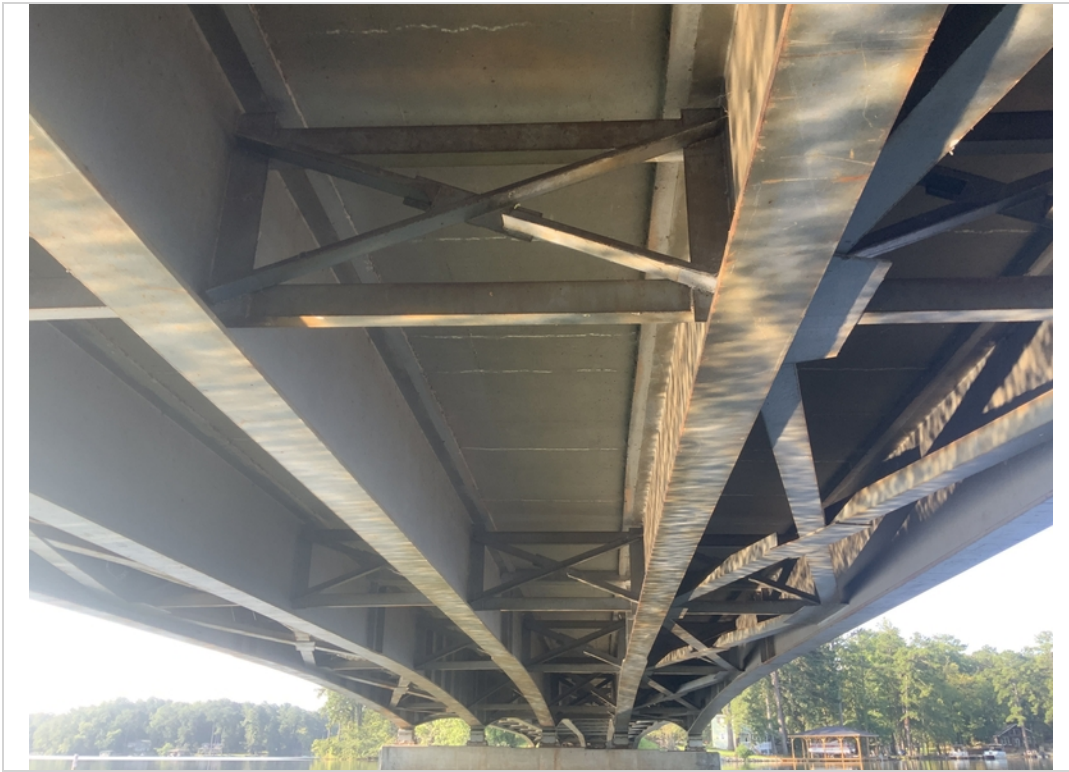
Soffit:
Bottom of deck has minor transverse cracking with minor efflorescence in all bays.

Span 3 soffit efflorescence. 2023

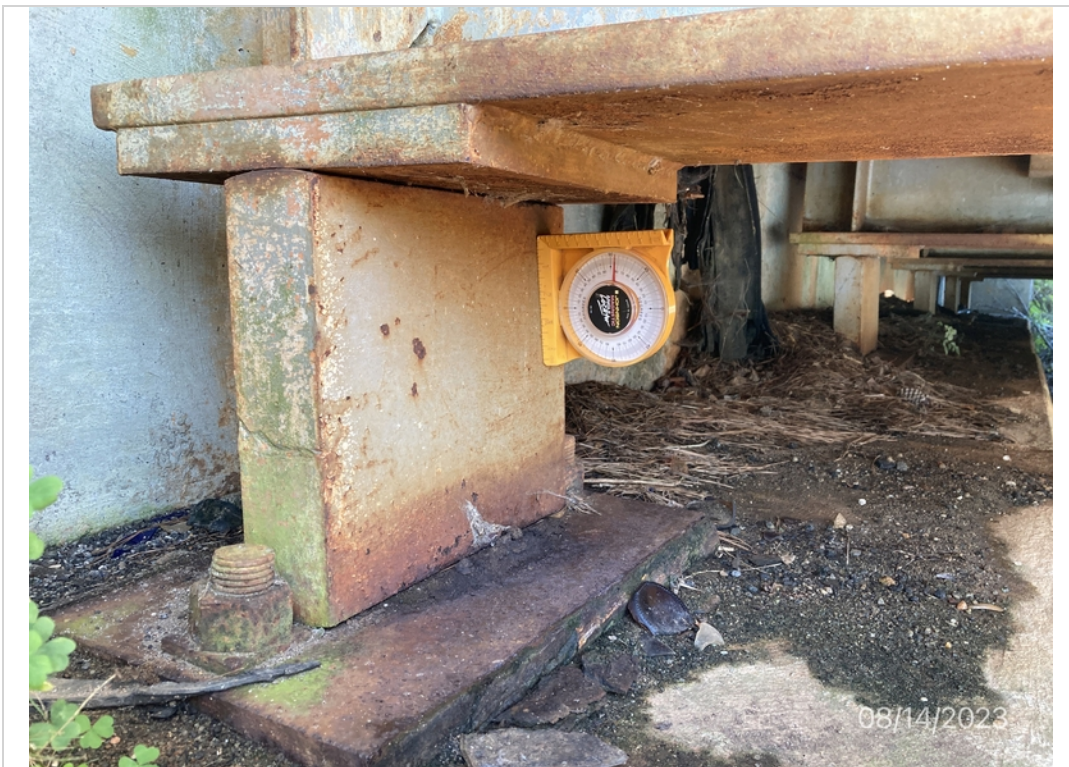
Abutment 1, rocker bearings are tilted 2 to 4 degrees to the rear.
Abutment 4, rocker bearings are tilted up to 5 degrees forward.
Abutment 4, bearing 5 has moderate rust; masonry plate has sheet corrosion with minor section loss. (photo)
Abutment 4 beam 5 right and left side anchor bolt 100% section loss

Abutment 1 rocker bearing tilt. 2023

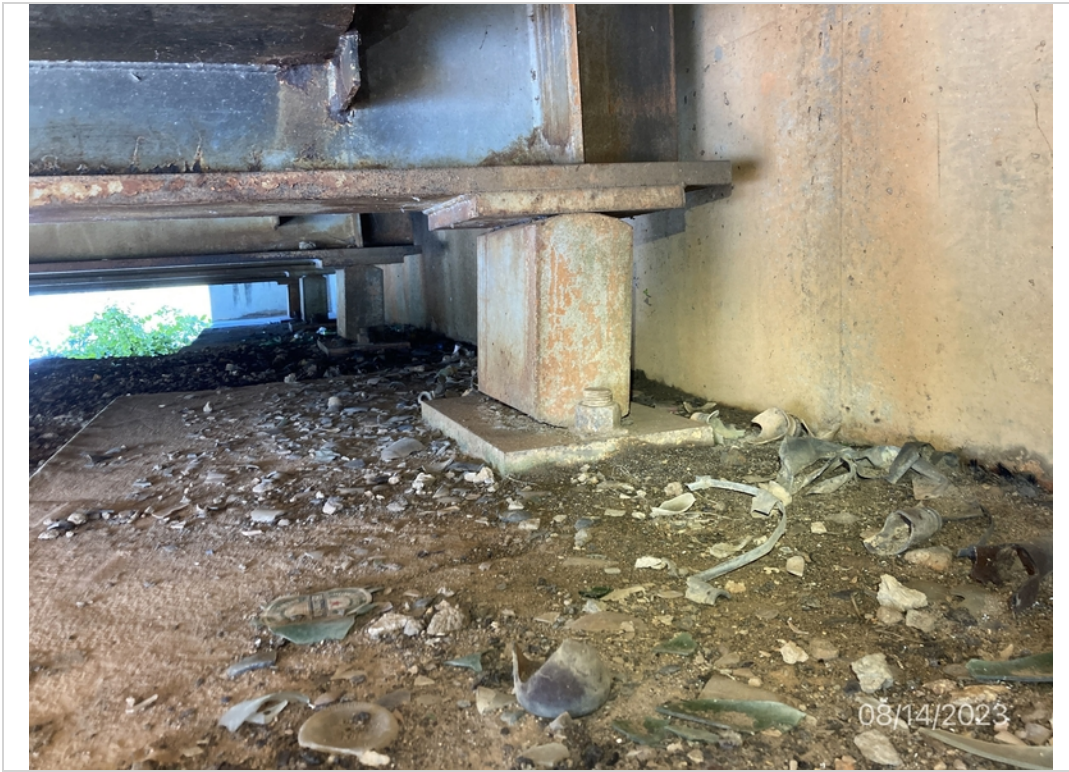
Abutment 4 bearing 5. 2023

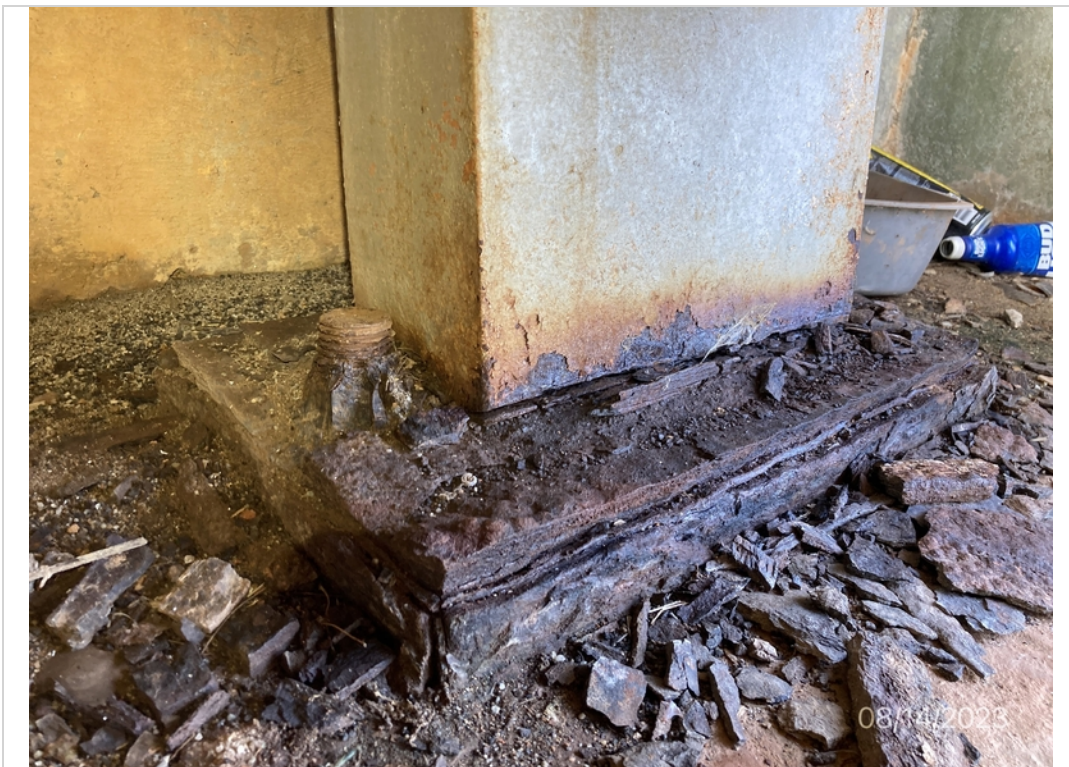
Abutment 1 bearing 5. 2023

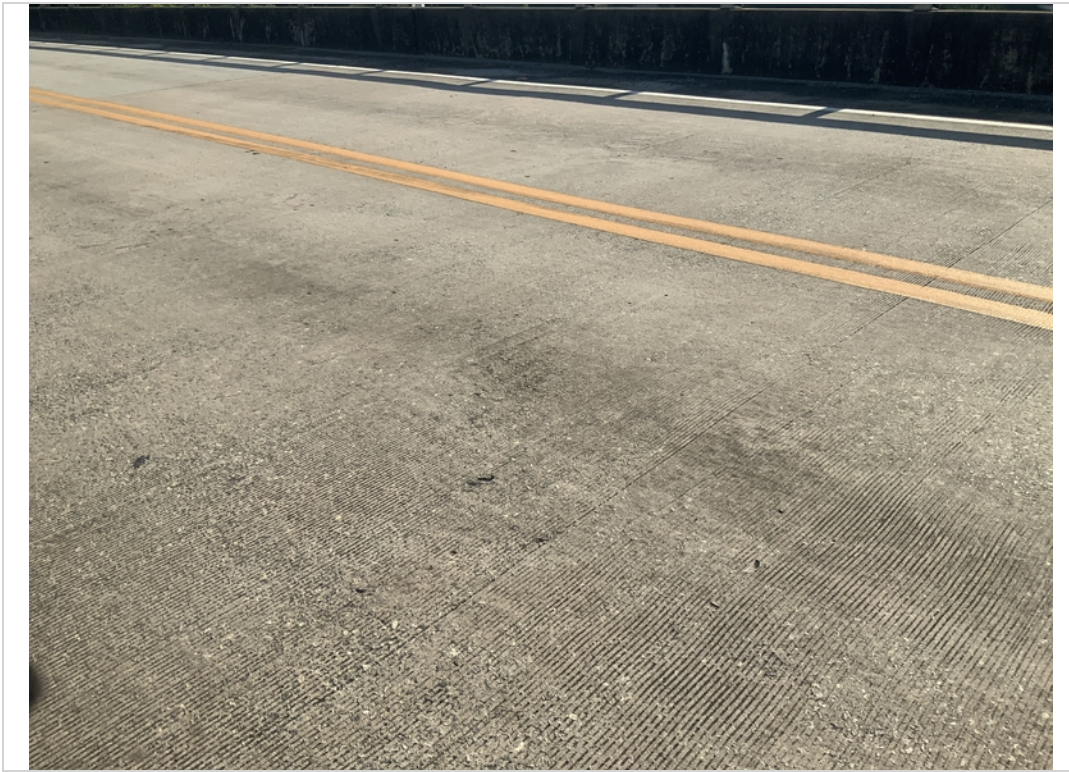
Deck top:
Minor shrinkage cracking.
Hairline to minor transverse cracking spaced approximately 3.0' to 4.0' apart, mixed with hairline longitudinal cracking over large portions of the deck.

Span 3 transverse. 2023

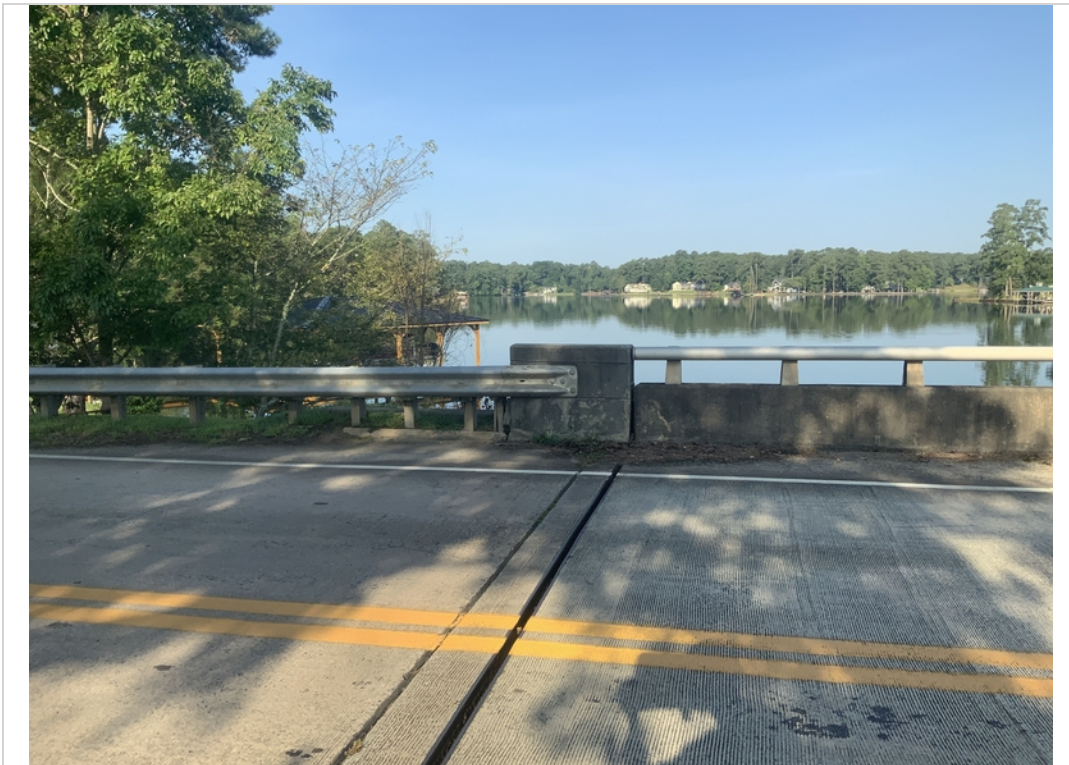
(71) Waterway Adequacy	8
(72) Approach Roadway Alignment	6
(36A) Bridge Railings	1-Inspected feature meets currently
(36B) Transitions	0-Inspected feature does not meet c
(36C) Approach Guardrail	0-Inspected feature does not meet c
(36D) Approach Guardrail Ends	0-Inspected feature does not meet c

Typical bridge rail transition. 2023

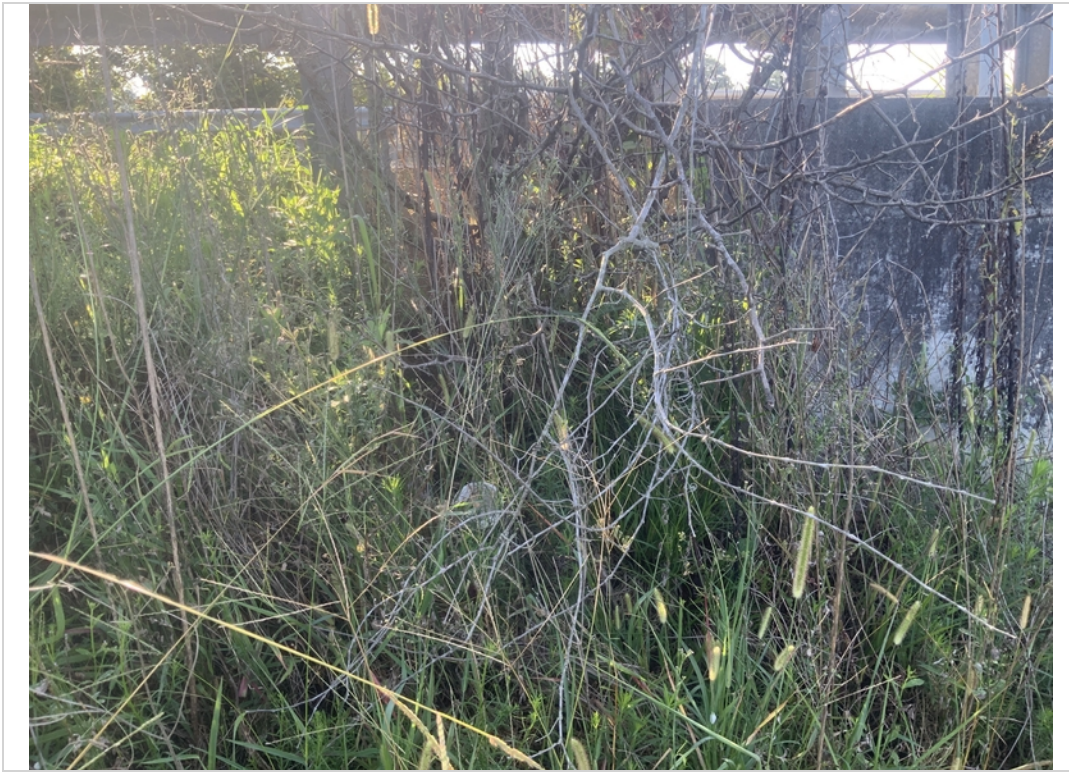
Erosion hole 2.0' deep at left side of abutment 4, extending 2.0' under the approach slab (between approach slab and end post where water is entering.). This extends under abutment 4 cap (see photo).

Forward left erosion hole 2.0' deep at left side of abutment 4 extending 2.0' under the approach slab (between approach slab and end post where water is entering). This extends under abutment 4 cap also. (see photo).

Forward left erosion under forward approach slab. 2023

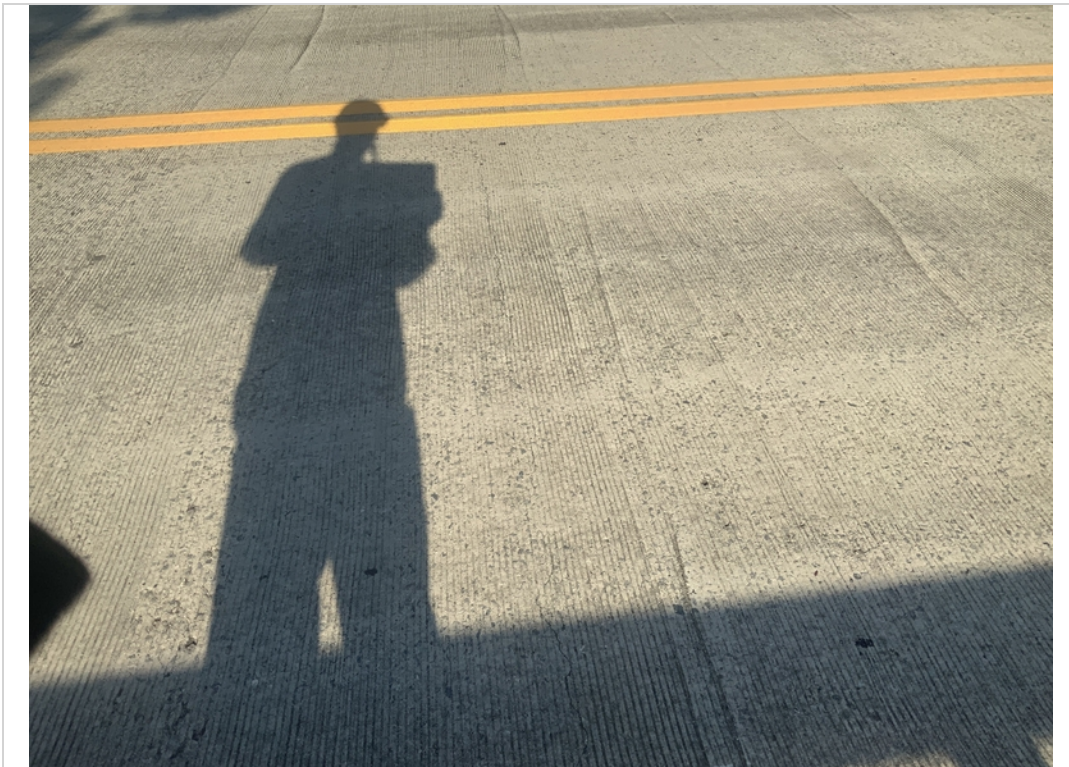
Span 1 transverse. 2023

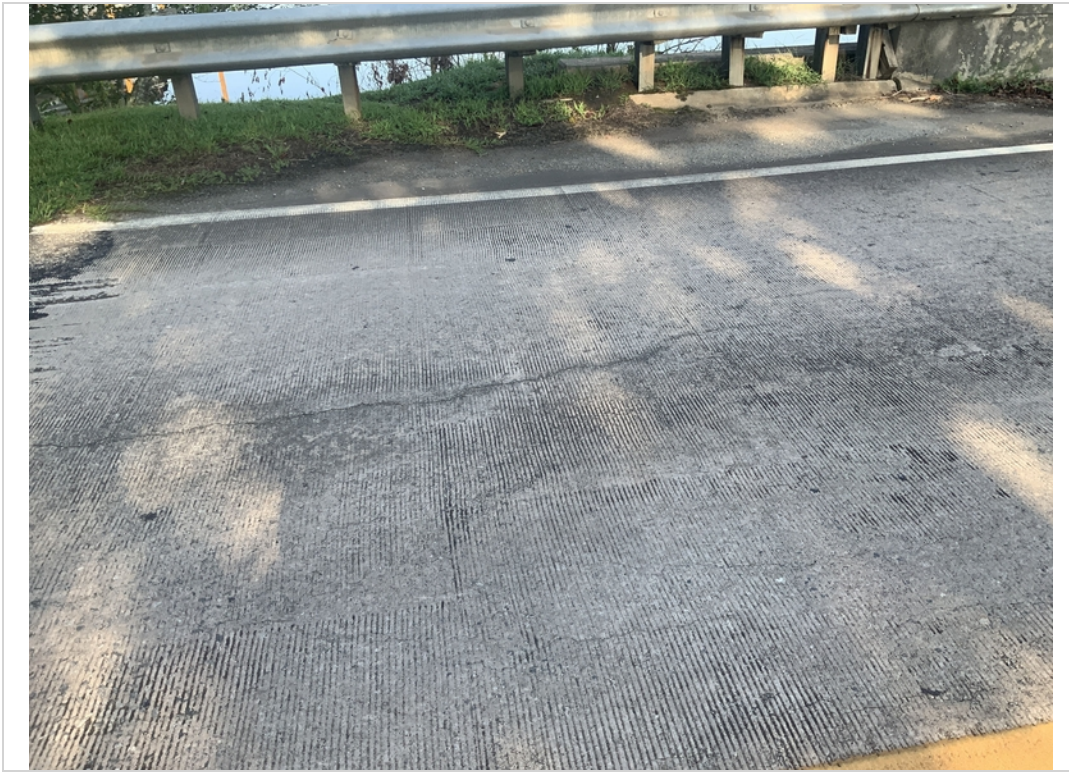
Both approaches have longitudinal and map cracking.

Rear approach slab longitudinal cracking. 2023

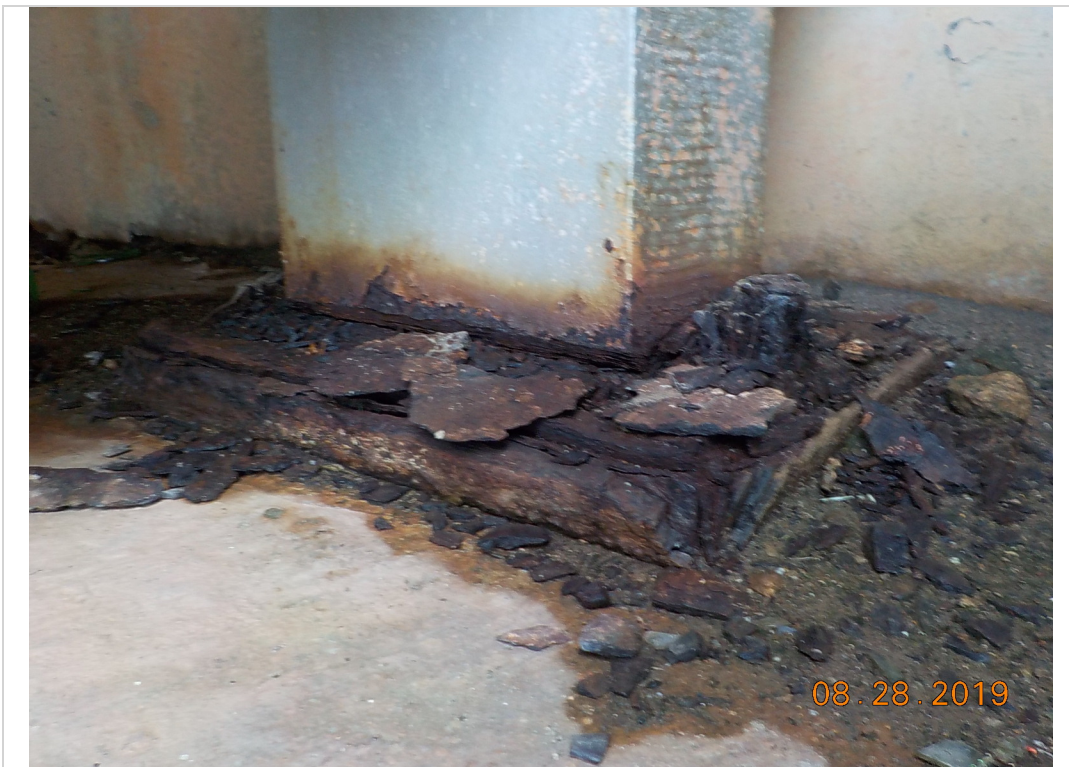
Abutment 1 Bearing 5

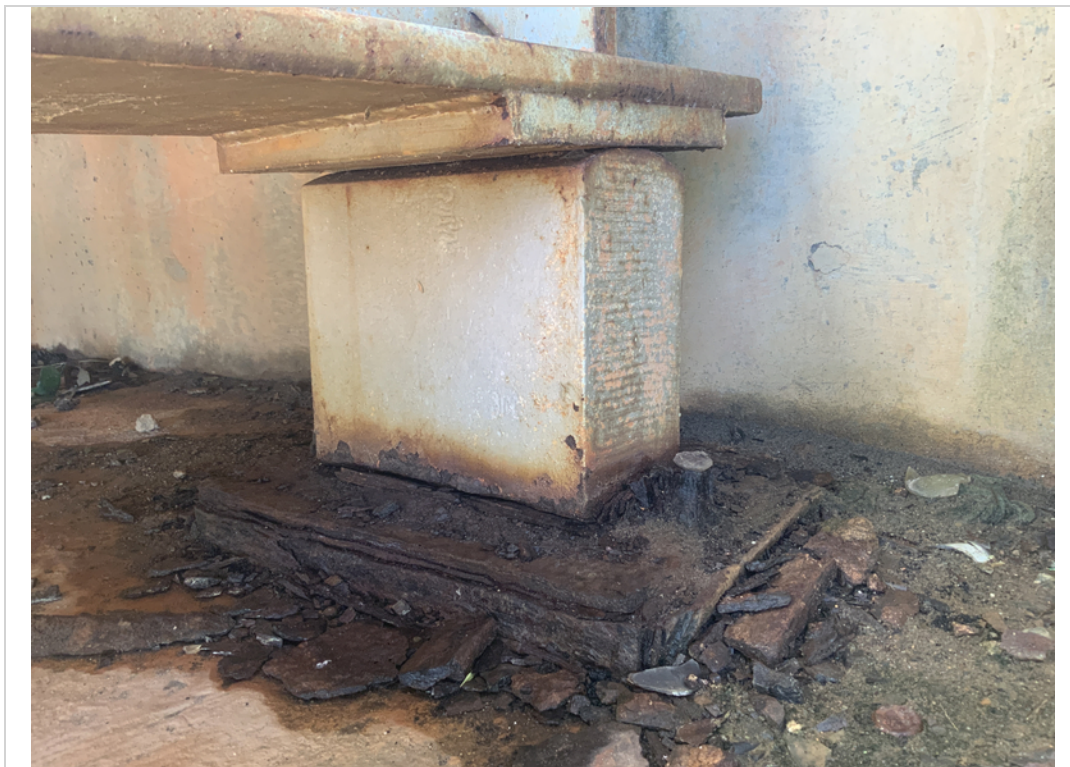
Abutment 4, bearing 5 corrosion. 2021

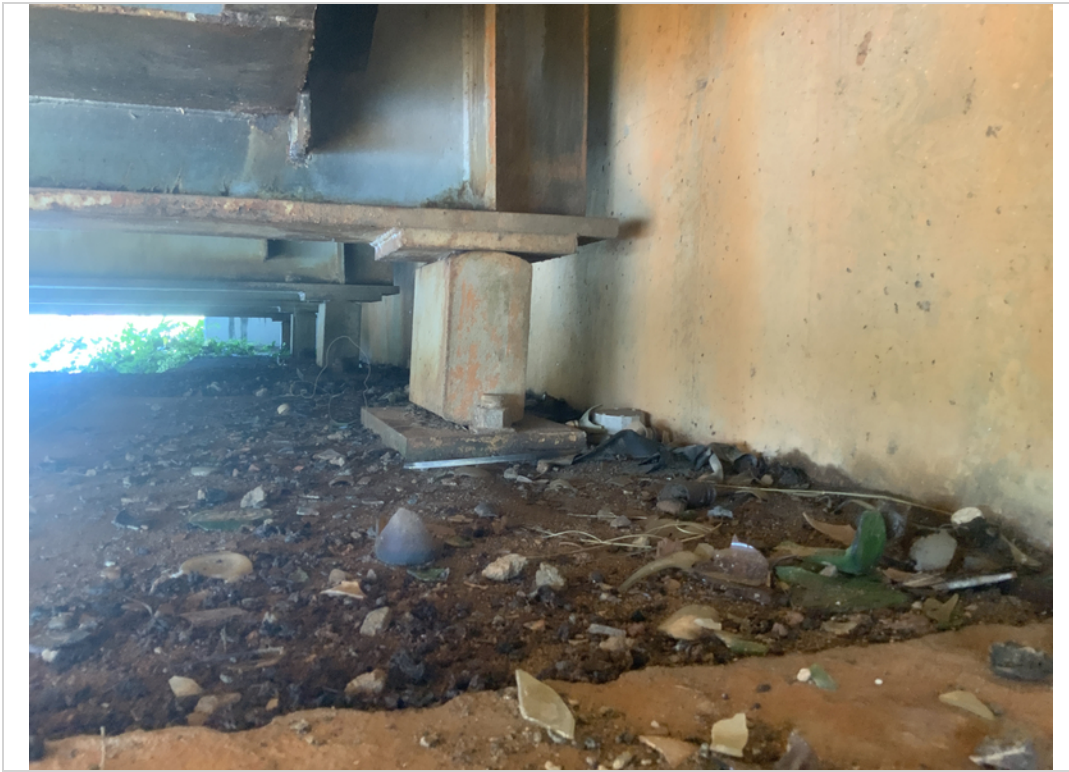
Abutment 4, rocker bearings. 2021
